Manhole Inspection Summary

Manhole # S17KK_012MH

Insp Date: **6/7/07 9:28 AM**

Location Address: **1901 RUXTON AVE**

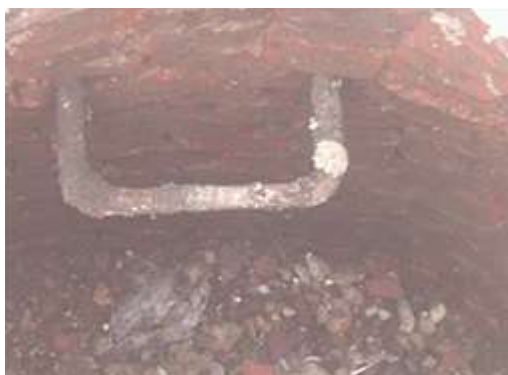
Defect 2

Steps Count: **1** Missing: **0** ☒ **Corroded**

CORRODED STEPS

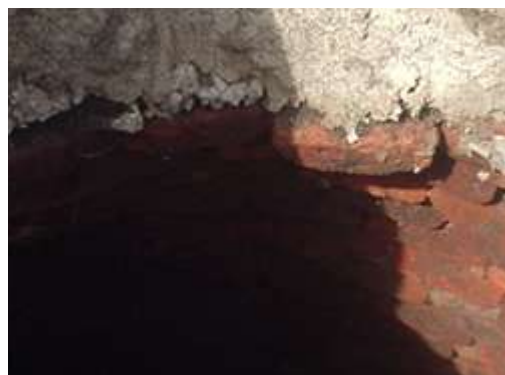
Defect 1

Condition: ☐ Sound ☐ Cracked ☐ Root Intrusion ☒ **Loose Brick** ☐ Deteriorated

LOOSE CORBEL BRICKS

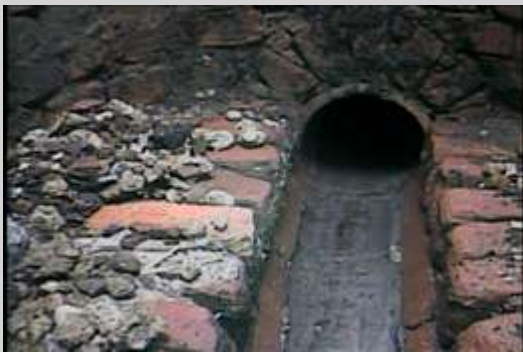
12 O'Clock Outflow

8 in. Circular Gravity Sewer
Pipe Out @ 12 O'Clock

DEBRIS ON BENCH AND IN CHANNEL

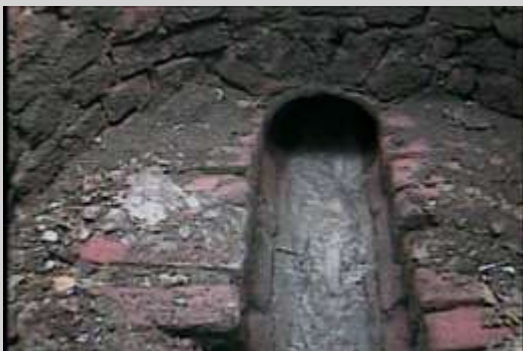
6 O'Clock Inflow

8 in. Circular Gravity Sewer
Pipe In @ 6 O'Clock

DEBRIS ON BENCH AND IN CHANNEL
